Issue Date  
15/03/2017

## **Service News (Issue 46)**

### **Helping you to fix it right the first time**

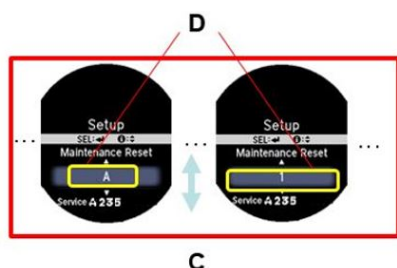
#### Additional changes to the SvRS system reset procedure

- C. Item RESET
- D. Independent item RESET.

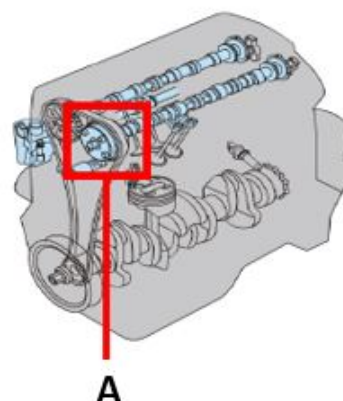
#### VTC Actuator Rattle Noise - HR-V Petrol 1.5 litre 2016YM

Some customers might complain of a rattle noise from the engine shortly after a cold start. This can also occur when the vehicles has been parked overnight or for 12 hours or more.

If you have eliminated the engine auxiliary components, then it could potentially be the VTC actuator (A) which is the cause of this abnormal rattle noise.

If you confirm the noise is from the VTC actuator, then replace it according to MarIS.

**Care Point:** After VTC Actuator replacement, you should carry out the CKP Pattern Clear/CKP Pattern Learn Procedure according to Maris, otherwise the ECM data could be corrupted and set DTC P0341.

The VTC Actuator part number is: 14310-5R1-013

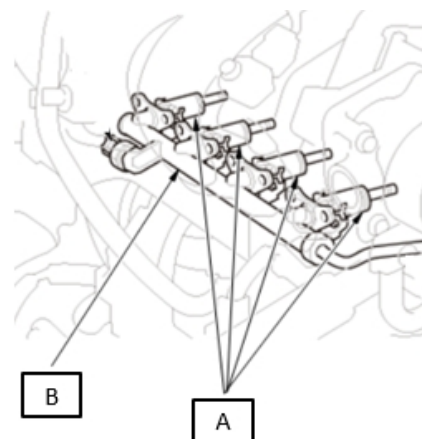
If one injector fails you must replace all four injectors (A), as the fuel rail (B) is supplied as a set.

If you remove the fuel injectors for any repair or maintenance, you should note the cylinder number of the fuel injector and ensure it is refitted to the same cylinder when reinstalling.

Note: Always use new clips and seals as the system operates at high pressure.

Web EPC only lists an Injector set, single injectors cannot be ordered separately.

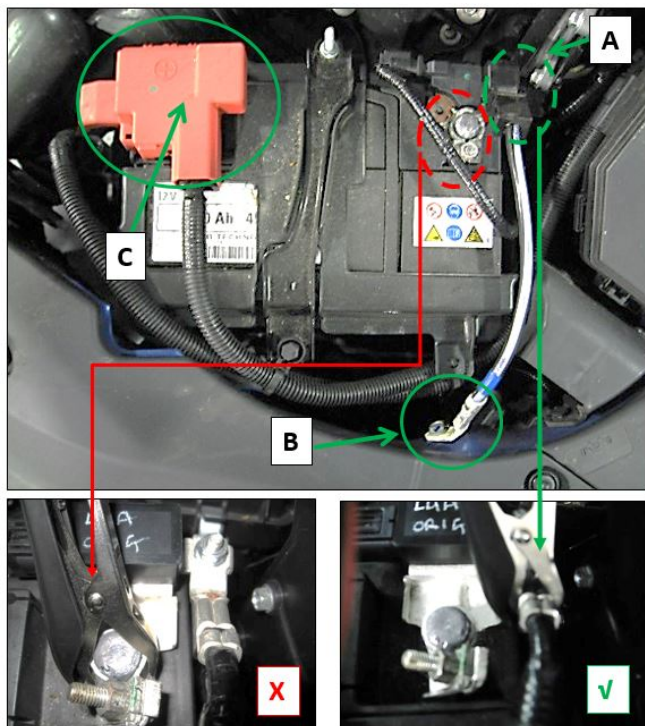
If auto idle stop is inoperative due to the low battery symbol, conduct the following special charging treatment that will recover an undamaged battery:

If the negative charger clamp is connected incorrectly on to the battery negative terminal the battery sensor will not detect the charging current flow. This will result in the Auto Idle Stop system being disabled by the ECM/PCM software logic.

The negative charger clamp should be connected to the body cable side of the battery sensor in position (A or B) depending on model and grade. The positive charger clamp should be connected to the positive battery terminal (C).

1. Battery charging must continue until the battery voltage level achieves 13.20 Volts or greater. (Use a multi-meter or the Midtronics tester to check the battery voltage)
2. A normal battery should achieve this level of voltage at 5 hours of charging using the Honda Midtronics ChargeXpress 25 battery charger.

If both conditions (1 & 2) above are met, the battery has recovered successfully and the charger can be disconnected.

**Note :** If Auto Idle stop is not available due to low battery after this charging process, replace the battery and recharge it using the steps above.

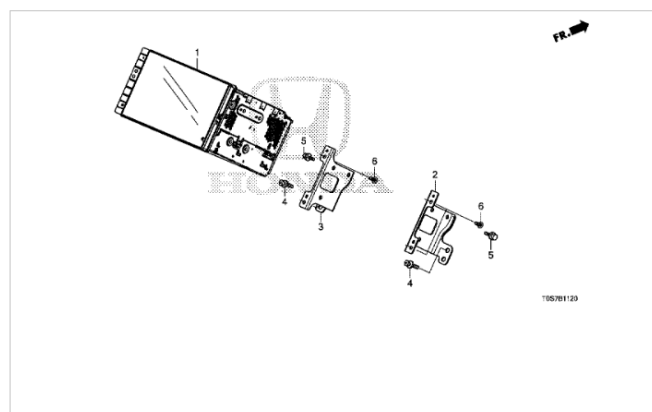
### Incorrect (16YM):

2016YM CRV audio unit, display has the wrong part number / Description in Parts Catalogue, instead of (Turkey) in the brackets it has (Nordic Kit) in brackets.

There is no (Nordic Kit) Sat Nav units and the T1E part number is only for the Turkish market.

**Note:** WebEPC Parts Catalogue will be corrected in the near future. In the meantime do not order (Nordic Kit) Audio Unit, Display, unless you are fitting it to Turkish specification CRV.
